**Re: GE-Pittsfield/Housatonic River Site
East Street Area 2-North (GECD140)
Revised Grant of Environmental Restriction and Easement – Post-Work Notification
Building 100 Utility Emergency Repair Project**

GENERAL ELECTRIC COMPANY
PITTSFIELD, MASSACHUSETTS
EAST STREET AREA 2-NORTH
POST-WORK NOTIFICATION

**APPROXIMATE LOCATION OF
COMPLETED EMERGENCY EXCAVATION**

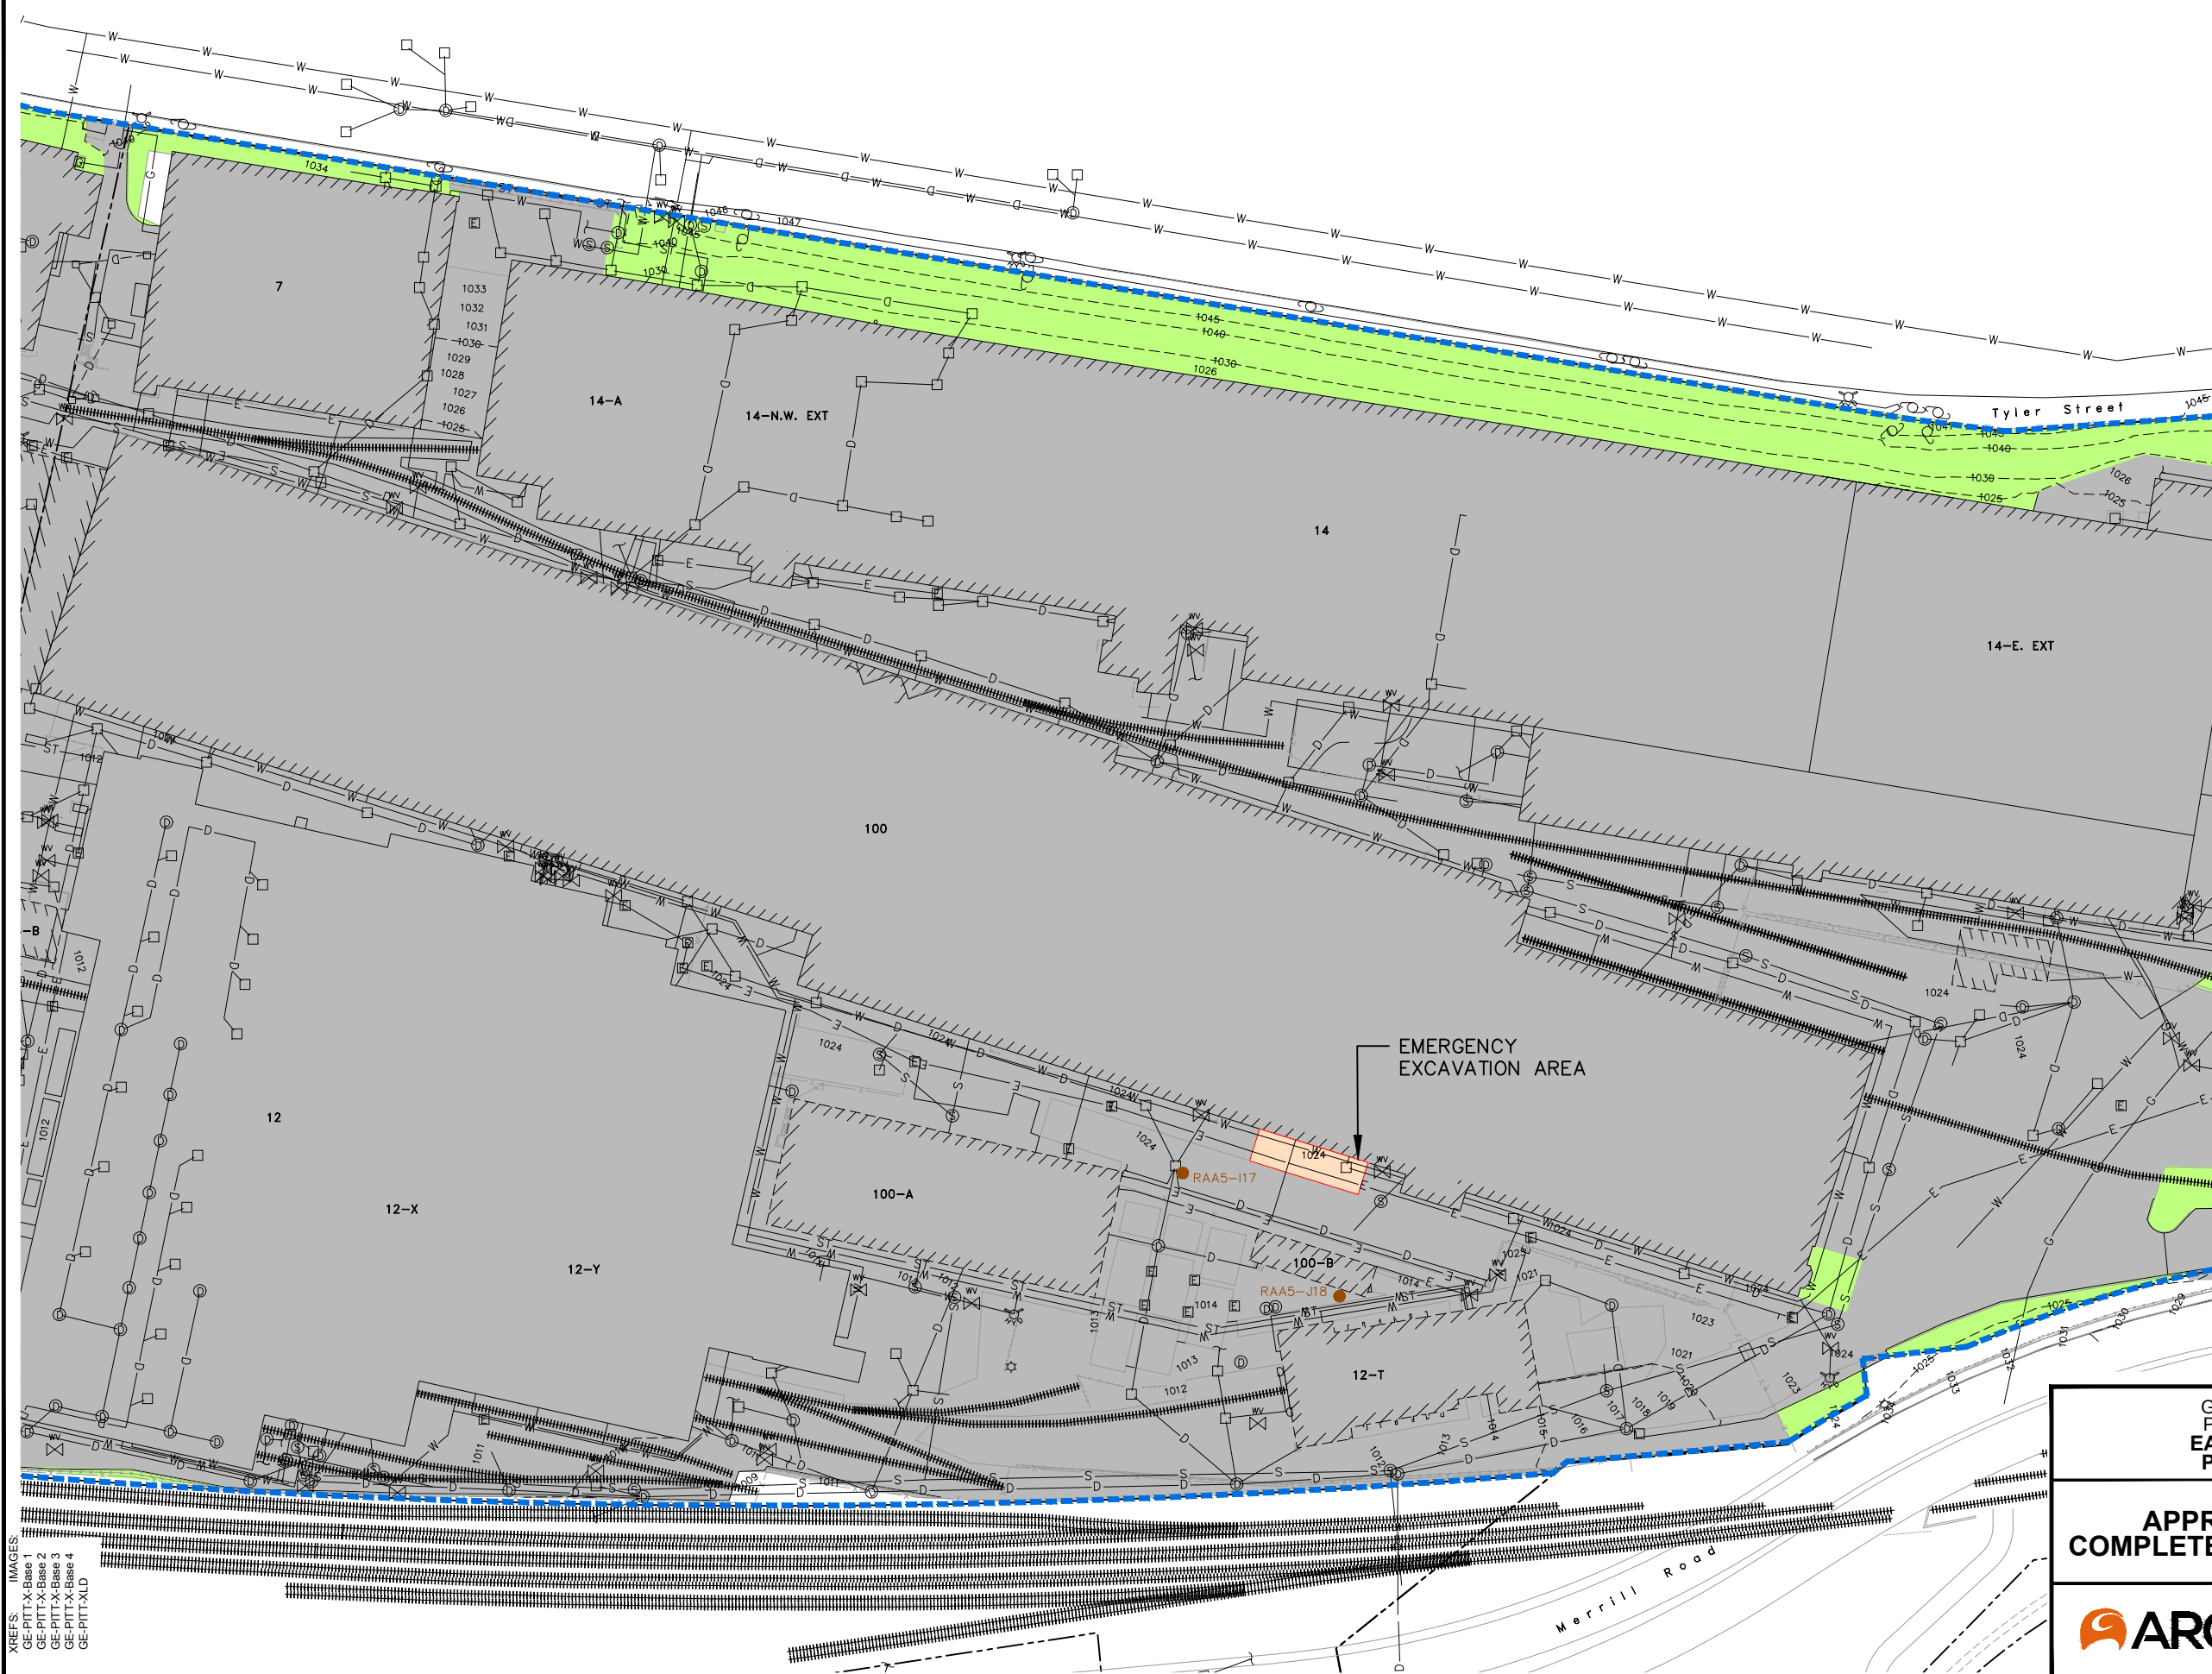
FIGURE
1

Final excavation dimensions were approximately 8 feet long (parallel to Building 100), 6 feet wide, and 7 feet deep, equating to approximately 13 cubic yards of excavated material. Figure 1 shows the location and orientation of the completed excavation. The excavation was subsequently backfilled, first with soil that was excavated from below one foot. This material was generally replaced in the same depth increment from which it was excavated. Imported clean soil was used to restore the uppermost one foot. The excavation area was then paved with new asphalt on May 23, 2018.

As outlined in GE’s notification and email correspondence, GE initiated repair activities at the Property on May 18, 2016. Excavation activities were conducted in the roadway immediately south of Building 100. Work was performed within an area identified as an “Other Ground Cover Feature” in the Revised Grant. After the fire protection line was isolated and drained to the extent practicable from nearby hydrants, excavation commenced. The surface soils in the vicinity of the water main break were displaced by the discharged water, and subsequently swept up for offsite disposal. Excavation of soil deeper than 1-foot continued until the twelve-inch diameter ductile iron fire protection pipe was uncovered at approximately six feet below existing ground surface. The damaged section of pipe was removed and replaced.
